# A. E. Wiggins Hipp Clock

*Richard Watkins*

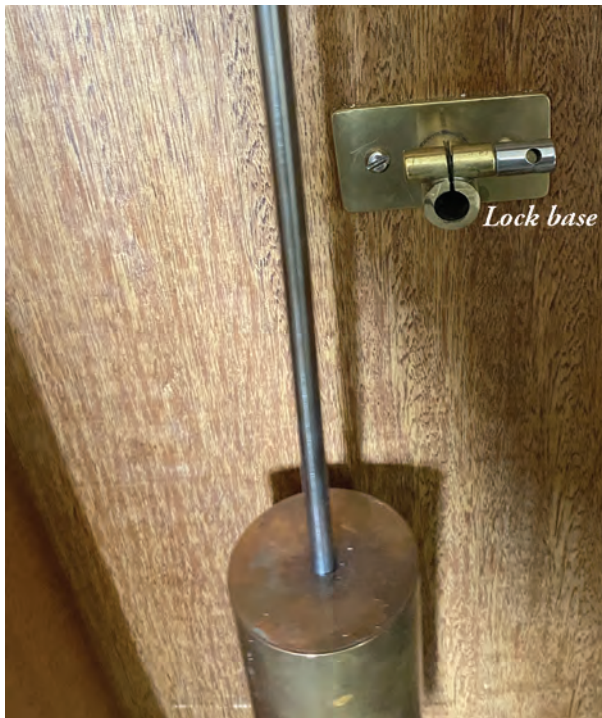
*Figure 1-1 Pendulum lock base*

Figure 1-1 shows the lock base and Figure 1-2 shows the pendulum lock beneath the shelf.

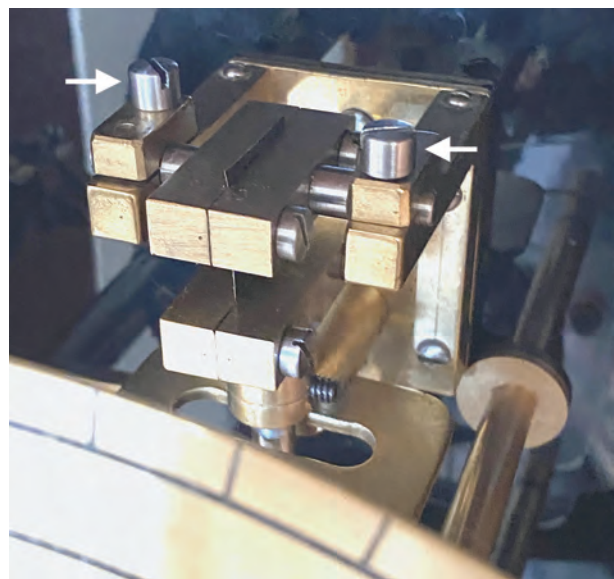
*Figure 1-3 Bolts for the Pendulum spring*

1. Loosen the two bolts for the pendulum spring, Figure 1-3. This enables the pendulum rod to swivel front and back. They should *very* loose to manipulate the pendulum and allow it to rise a little without damaging the suspension spring.

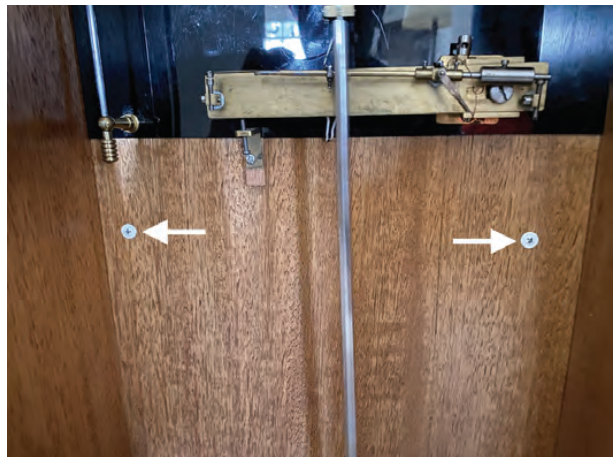
*Figure 1-5 Screws holding the case to the wall*

3. Look to see if the case is screwed to the wall. (Figure 1-5 shows the present screws.)

Remove these screws.

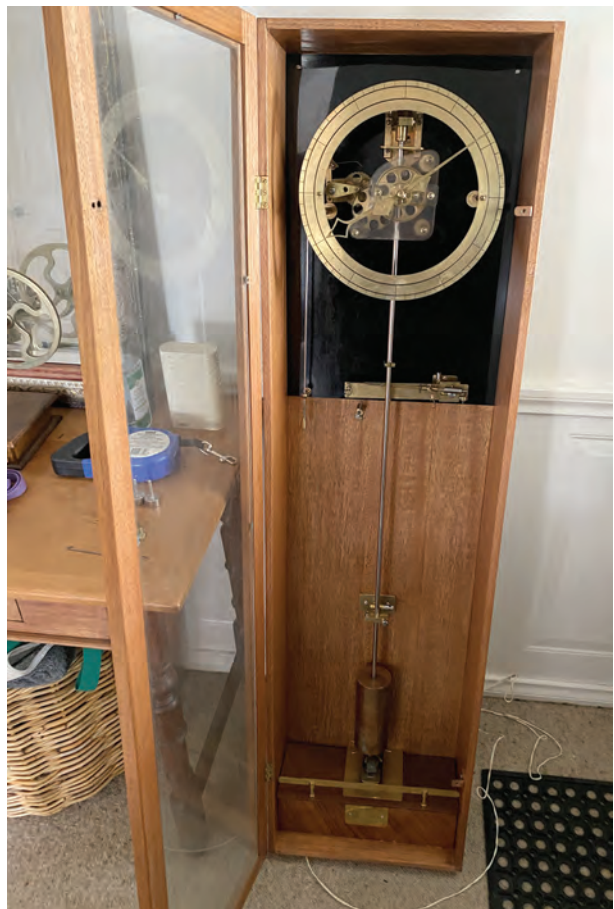
*Figure 2-1 As it was in my home*

The clock lived in the back of my car for a couple of days, and then it was leant up in the hall; Figure 2-1.

In Figure 2-1, about a third of the way down, at the bottom of the black plate, there is a *toggle* (as many people call it) which acts as a switch to power the electromagnet.

The purpose of the brass lever on the left hand side, Figure 2-1, was a mystery. It operated a steel wire that sometimes landed on top of the first wheel, a ratchet wheel connecting the pendulum to the motion works and did nothing, just following the turns of the first wheel. (The Hipp clock has only motion works because the pendulum drives the clock and not the clock drives the pendulum as in normal clocks.) And sometimes the wire would get caught up in one of the holes in the first wheel and stop it moving, which is obviously a disaster. I was puzzled about this and could make no sense of the purpose of the lever.

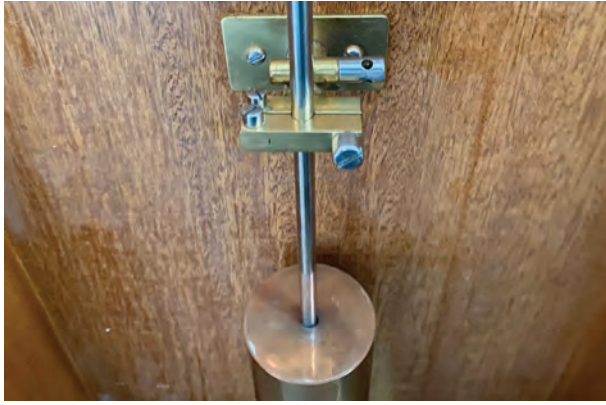
Figure 2-2 Pendulum locked

Then I investigated the shelf at the bottom of the case, covering most of the electromagnet. It was removable and I found five bits in there. Most important was a lock for the pendulum, Figure 2-2, which I installed instantly even though the pendulum spring had broken. It is a pity that the pendulum lock hadn't been installed when the clock was taken to the auction and, of course, it would have prevented the damage.

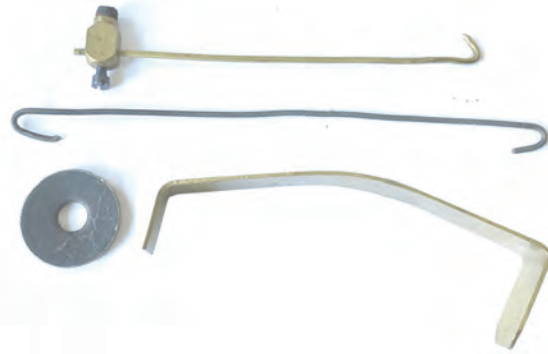
Figure 2-3 Miscellaneous bits

There was also another four bits, Figure 2-3, and I preserved them to contemplate them afterwards. It was at that time that I realised that they didn't belong to the clock and they were random bits of detritus. Top is a striking lever for a cheap clock (probably American) and the steel washer (lower left) is bit of miscellany. I have no idea what is the use for the brass clamp, bottom right or the wire second from the top.

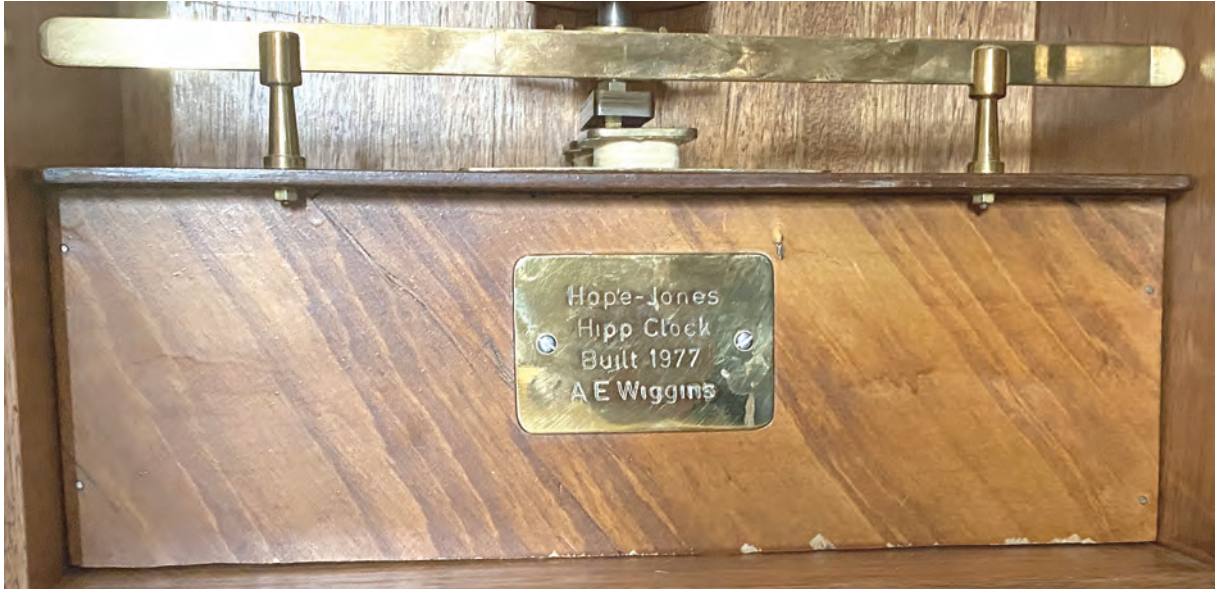
*Figure 3-1 The shelf front*

The shelf front is shown in Figure 3-1. Note the errors. First, the front is made of varnished plywood and there are four big chips in the base plus many minor ones. Second, the height of the left-hand end is 105 mm ( $4\frac{1}{8}$  inches) and the right-hand end is 109 mm ( $4\frac{3}{8}$  inches).

The cut-out in shelf in position, Figure 3-6, is too wide at the left. Figure 3-1 shows that the shelf is approximately half way up the electromagnet coils and there is no need make the cut-out wide for the red wires and it should be closer to the electromagnet.

As the shelf was decorative (mainly to hide the electromagnet) I didn't change it.

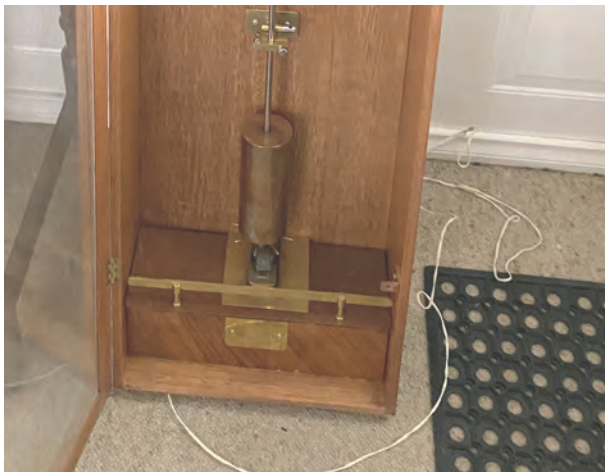
Figure 4-2 The tangle of white wires

I had removed the shelf in the bottom of the case and I was confronted by a tangle of white, copper wires that someone incompetent had done. The white wires leading from the electromagnet out of the back of the case to the toggle were neat and rebated into the back of the case.

But the identical pair white wires that once led to the power source were bare and were twisted around the bare wires to the power supply and toggle switch, Figure 4-1 green lines and Figure 4-3. The wires are stiff so there was no immediate problem, but if they had touched! The pair of white wires led through a hole in the bottom of the case and were about 2.4 metres long (8 feet) ending in nothing, but a power supply should have been connected; Figure 4-2.

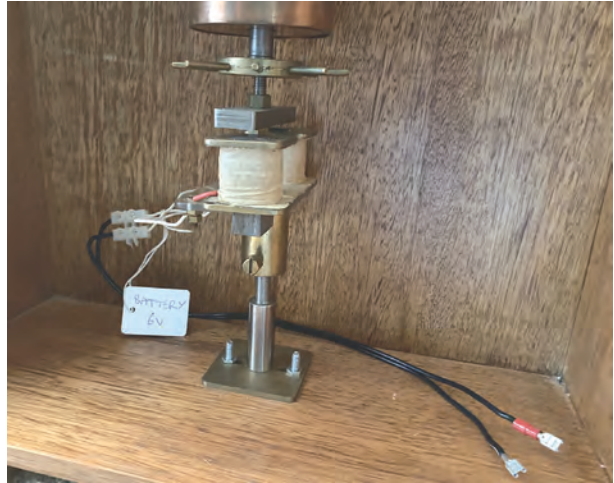
*Figure 4-4 Electromagnet after wiring tidied up*

The electromagnet is off centre, Figure 4-4 and 8-1, page 26. It is probably intentional because the pendulum, when it switched the power on, receives an impulse from the magnet.

As there was plenty of space below the shelf for a rechargeable battery or two, I tidied up the wiring and connected a pair of black wires through a junction box to have a battery added, Figure 4-4.

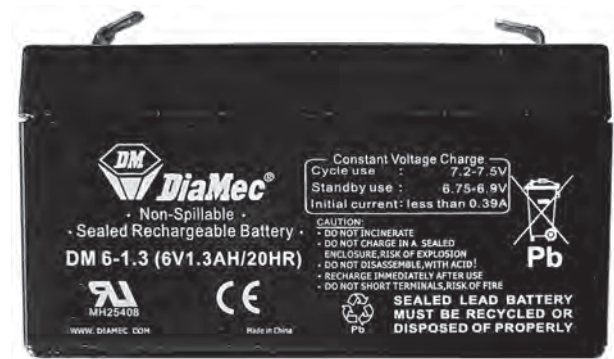
*Figure 4-5 The battery*

I got two 6 volt lead-acid batteries and a charger. The batteries are about 60 mm high, allowing for the connectors, 98 mm wide and 25 mm deep; Figure 4-5.

How long the battery lasts depends on the frequency of the impulses (page 22). At present one small battery lasts for over a month.

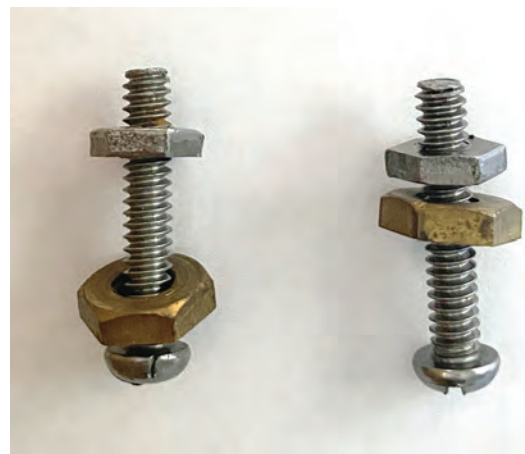
*Figure 4-6 Old bolts holding the electromagnet*

The electromagnet, Figure 4-4, is on an adjustable post with the screw heads and nuts outside the case bottom; the old, bad bolts are shown in Figure 4-6. This is the second reason there must have been a plinth on the bottom of the case. I replaced the bolts by two countersunk bolts to avoid using a plinth, Figure 4-7. (There may have been a plinth at the auction, but I don't think so.)

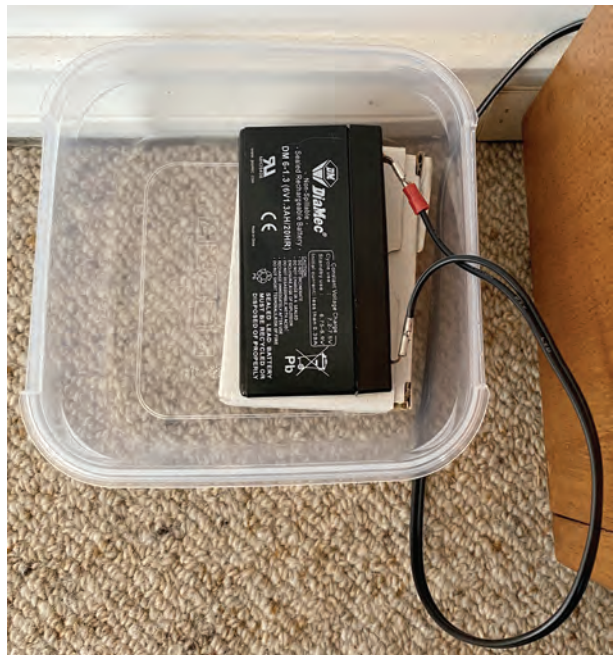
*Figure 4-8 Battery location beside the clock*

Later I realised that Wiggins was right, putting the power supply outside the case. The door needs to be closed for at least 6 months and with the battery below the shelf, Figure 4-4, I would have to open the door to replace the battery.

So I drilled a small hole in the back of the case below the shelf and used a battery outside the case, Figure 4-8. (Most houses have skirting boards so the clock case will have space at the back. Lacking skirting boards they can be added. Note, there has to be a piece of timber about halfway up the clock to fix it to the wall; although unlikely, the clock case can topple. So I have two screws to fix the case onto the wall and prevent it toppling.

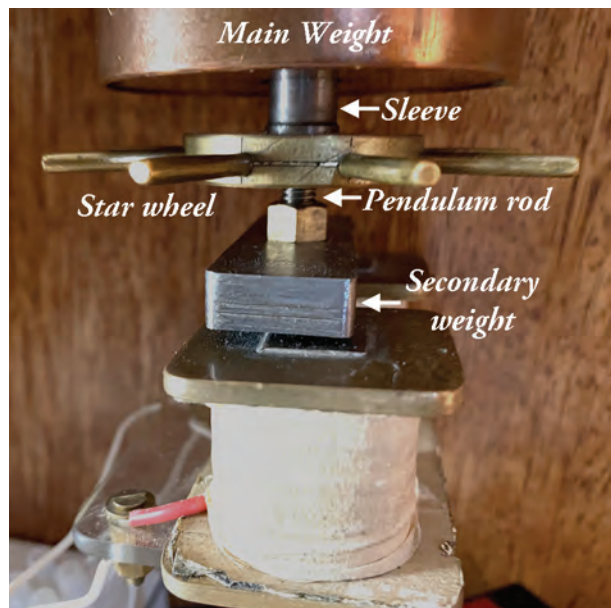
*Figure 5-6 Action of the Star Wheel*

The main weight is loose in a steel sleeve about 11 mm in outside diameter and 8 mm inside diameter so it can move freely up or down depending on the position of the star wheel. (In the photo the main weight has been moved up to show the sleeve.)

The star wheel is threaded and it runs on the pendulum rod. It has a short, steel sleeve that the main weight rests on. Thus the star wheel lengthens and shortens the pendulum without effecting the position of the secondary weight.

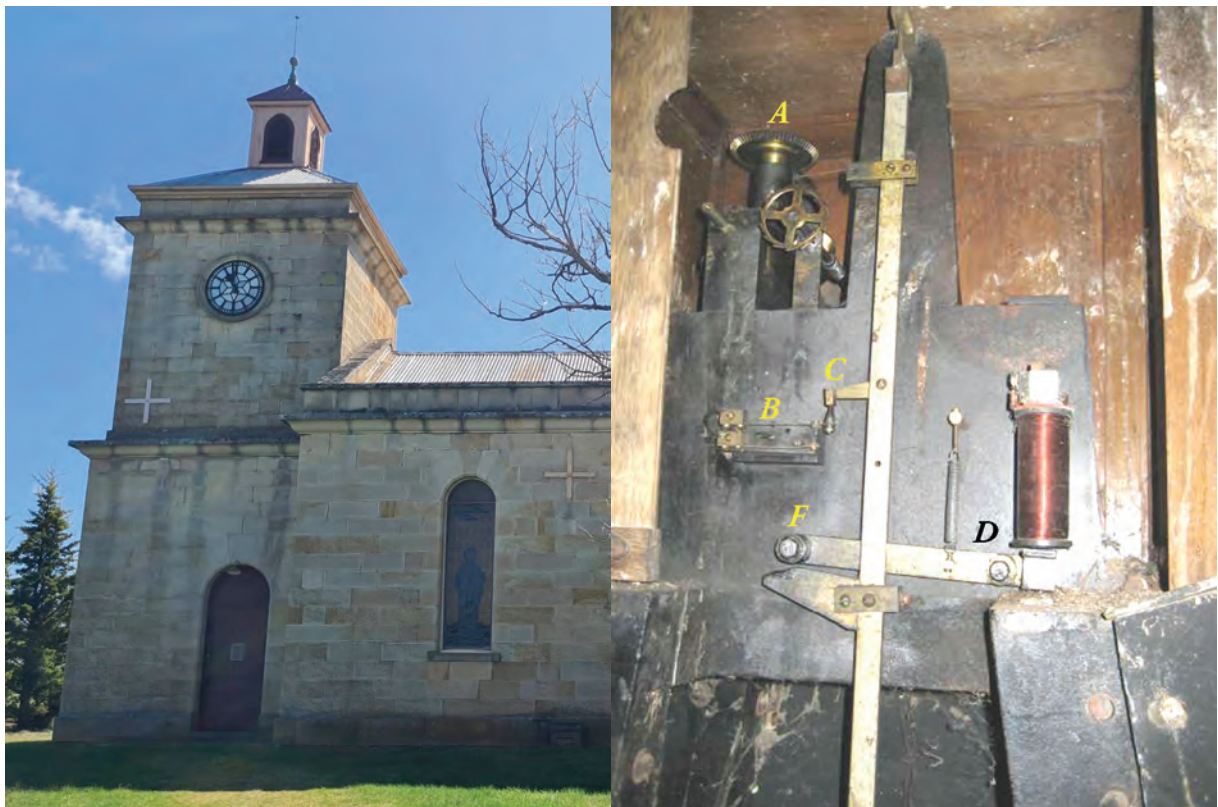
*Figure 7-10 The Avoca church and Hipp clock*

Figure 7-10 is of the Avoca (Tasmania) church and clock, installed in 1939.

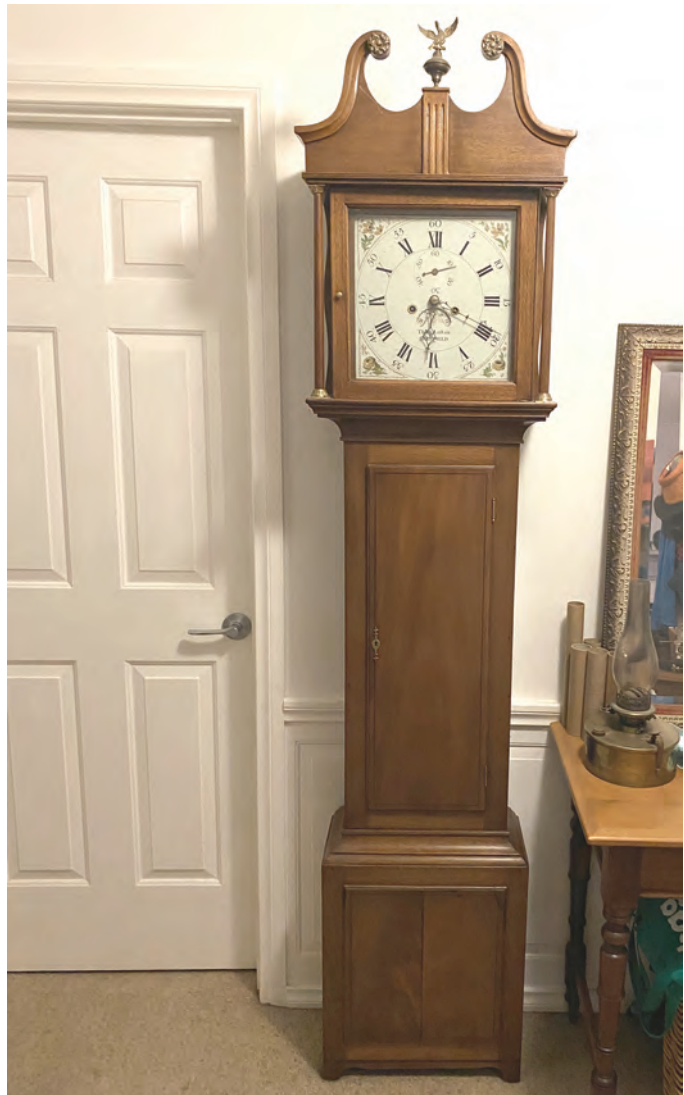
*Figure 8-2 Long case clock*

Even a light pendulum swinging will move the case in sympathy and may stop the pendulum swinging.

Which is why the case is screwed to the wall.

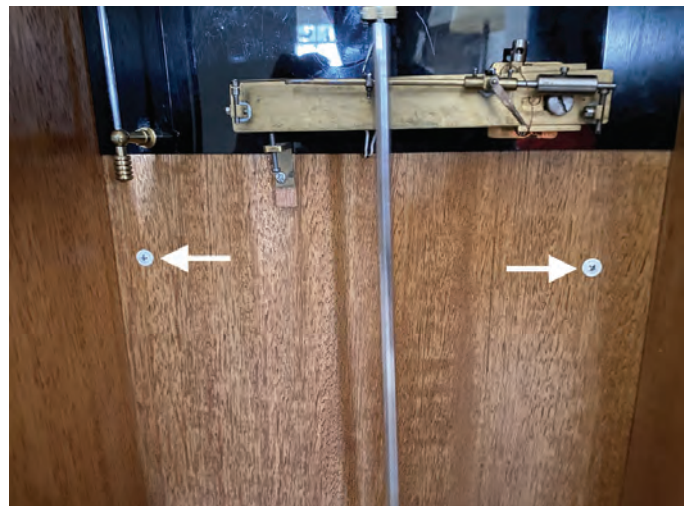
*Figure 8-3 Screws that hold the case to the wall*

The position for the Hipp clock is on another wall in the hall and likewise it is screwed to the wall, Figure 8-3, a necessity because the pendulum is much heavier and the case, which is on carpet, would move in sympathy.

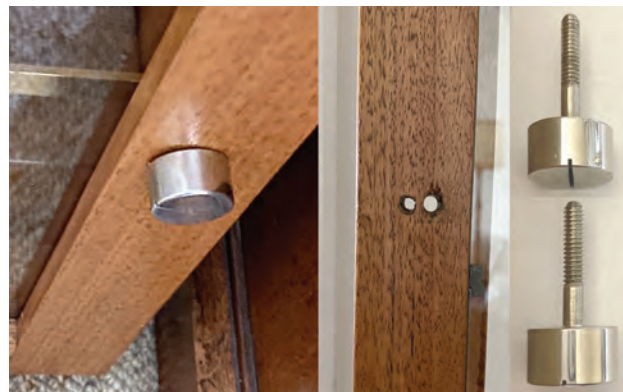
*Lower bolt                      Holes                      Bolts*  
*Figure 9-1 The door*

The door bolts (finely made) are out-of-square, obvious with the lower one. The threaded brass holes into which the bolts go were done incorrectly by a different person and added later.
